**Flood Control Project Maintenance
Levee Inspections**
LMA District Cover Sheet
Spring 2014 Levee Inspection Results

San Joaquin County Flood Control and Water Conservation District

Spring 2014 Levee Inspection Results

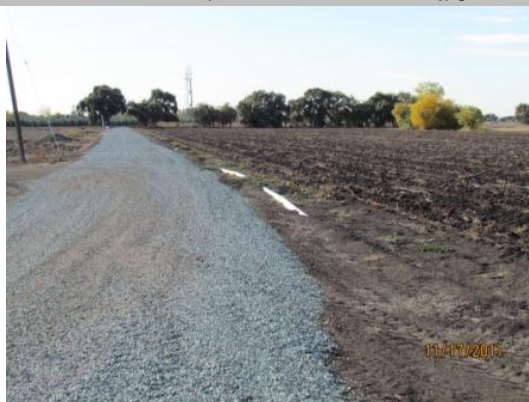
Photo 1 of 1 : pkazi_s_20140415_105.jpg

LM Start	1.07	Rating **	M	Issue No.	12
LM End	1.27	Issue Type +	En	Location *	WS
Category	Earthen Levee			GPS Latitude/Longitude	
				Start	End
Item	Encroachments			37.878425 °	37.877636 °
				-121.242593 °	-121.246147 °
DWR ID	DWR_NA0017_01_s _ 2012_12				
Action/Comments					
Pipe

PVC Pipe was found on the waterside of the levee looking downstream.

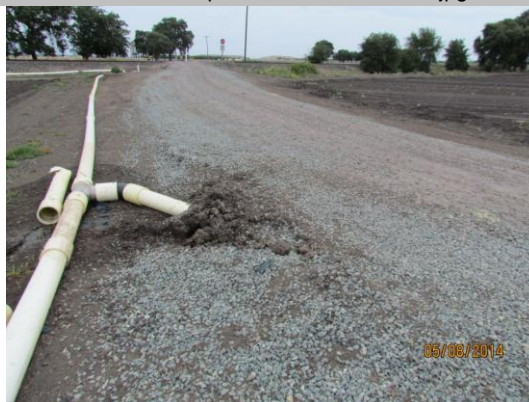
Photo 1 of 1 : pkazi_s_20140509_955.jpg

LM Start	1.10	Rating **	M	Issue No.	1
LM End	1.10	Issue Type +	En	Location *	WS
Category	Earthen Levee			GPS Latitude/Longitude	
				Start	End
Item	Encroachments			37.878409 °	37.878409 °
				-121.243185 °	-121.243185 °
DWR ID	DWR_NA0017_01_s _ 2014_1				
Action/Comments					
Pipe

A PVC pipe was found going through the levee alignment. The picture was taken from the crown looking upstream.

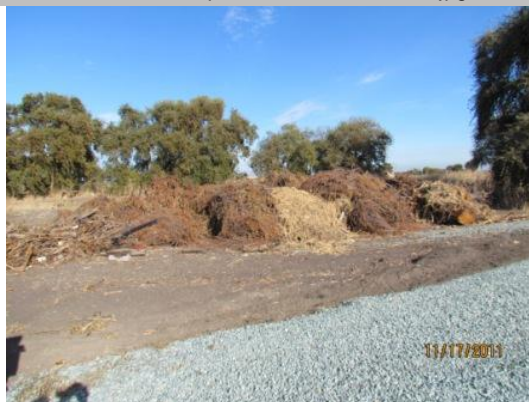
Photo 1 of 1 : pkazi_s_20140415_108.jpg

LM Start	1.32	Rating **	M	Issue No.	14
LM End	1.32	Issue Type +	En	Location *	WS
Category	Earthen Levee			GPS Latitude/Longitude	
				Start	End
Item	Encroachments			37.877724 °	37.877724 °
				-121.247054 °	-121.247054 °
DWR ID	DWR_NA0017_01_s_2012_14				
Action/Comments					
Prunings

Prunings were found on the waterside of the levee looking upstream.

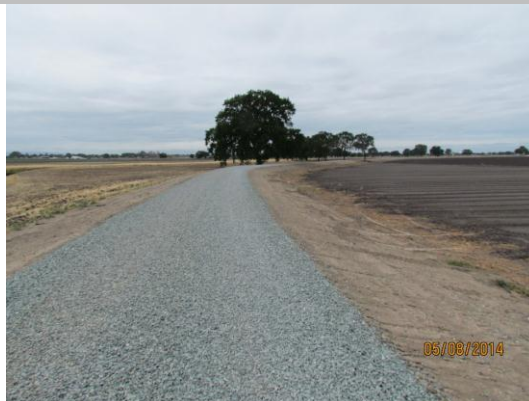
Photo 1 of 1 : pkazi_s_20140509_956.jpg

View of the landside of the levee looking downstream.

LM Start	0.96	Rating **	A	Issue No.	2
LM End	0.96	Issue Type +	Ma	Location *	LS
Category	Earthen Levee			GPS Latitude/Longitude	
				Start	End
Item	Vegetation			37.877185 °	37.877185 °
				-121.235168 °	-121.235168 °
DWR ID	DWR_NA0017_02_s_2014_2				
Action/Comments					
Control annual grass and weeds on the levee slopes and easements.

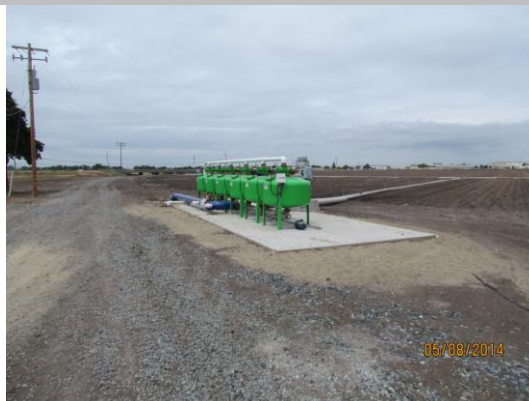
Photo 1 of 1 : pkazi_s_20140509_957.jpg

LM Start	1.72	Rating **	M	Issue No.	3
LM End	1.72	Issue Type +	En	Location *	LS
Category	Earthen Levee			GPS Latitude/Longitude	
				Start	End
Item	Encroachments			37.879548 °	37.879548 °
				-121.247397 °	-121.247397 °
DWR ID	DWR_NA0017_02_s_2014_3				
Action/Comments					
Equipment

Farming equipment was found on the landside shoulder of the levee looking downstream.

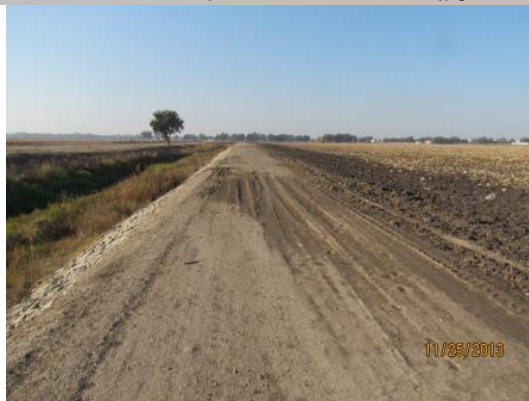
Photo 1 of 1 : pkazi_s_20140415_109.jpg

Crown depression was found looking downstream.

LM Start	2.01	Rating **	M	Issue No.	1
LM End	2.01	Issue Type +	Ma	Location *	CR
Category	Earthen Levee			GPS Latitude/Longitude	
				Start	End
Item	Crown Surface / Depressions / Rutting			37.882528 °	37.882528 °
				-121.250601 °	-121.250601 °
DWR ID	DWR_NA0017_02_f_2013_1				
Action/Comments					
Add appropriate gravel or road base. Grade and compact.

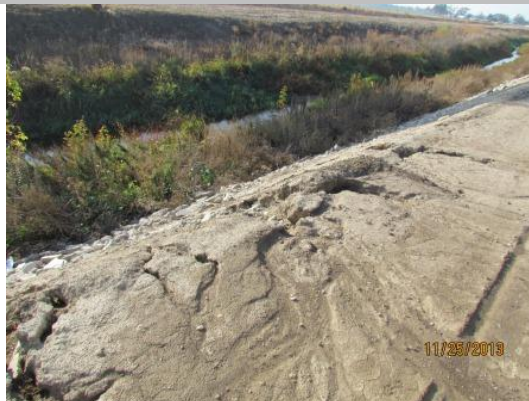
Photo 1 of 1 : pkazi_s_20140415_110.jpg

Erosion due to runoff was found on the waterside shoulder of the levee looking downstream.

LM Start	2.08	Rating **	M	Issue No.	5
LM End	2.08	Issue Type +	Ma	Location *	WS
Category	Earthen Levee			GPS Latitude/Longitude	
				Start	End
Item	Erosion / Bank Caving			37.883137 °	37.883137 °
				-121.251628 °	-121.251628 °
DWR ID	DWR_NA0017_02_f_2013_5				
Action/Comments					
Schedule repair of erosion site prior to the next inspection.

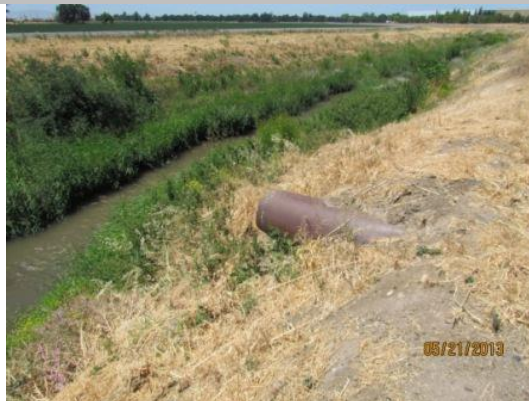
Photo 1 of 1 : pkazi_s_20140415_111.jpg

LM Start	2.66	Rating **	A/W	Issue No.	8
LM End	2.66	Issue Type +	Ma	Location *	WS
Category	Earthen Levee			GPS Latitude/Longitude	
				Start	End
Item	Encroachments			37.888853 °	37.888853 °
				-121.258640 °	-121.258640 °
DWR ID	DWR_NA0017_02_s _ 2012_8				
Action/Comments					
Pipe					
Inspector Comments: Pipe crossing the channel has corroded and can carry water to/from the channel. This pipe needs immediate attention but is likely an older encroachment and may predate the project.

A pipe was found without a flap gate on waterside slope of the levee looking downstream. This pipe may predate the project.

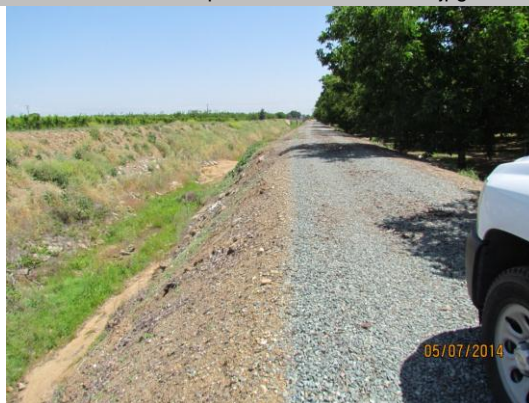
Photo 1 of 1 : pkazi_s_20140512_972.jpg

View of the waterside slope of the levee looking upstream.

LM Start	0.02	Rating **	A	Issue No.	1
LM End	0.02	Issue Type +	Ma	Location *	WS
Category	Earthen Levee			GPS Latitude/Longitude	
				Start	End
Item	Vegetation				°
					°
DWR ID	DWR_NA0017_06_s_2014_1				
Action/Comments					
Control annual grass and weeds on the levee slopes and easements.

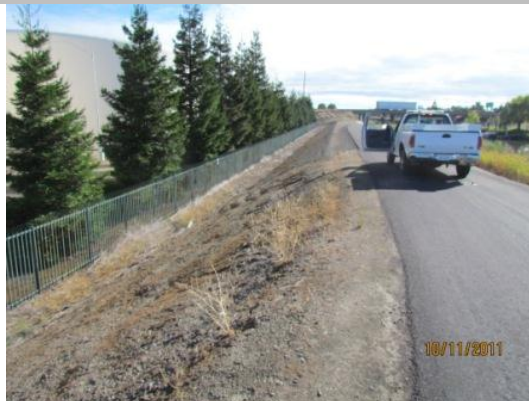
Photo 1 of 1 : pkazi_s_20140415_112.jpg

LM Start	0.39	Rating **	M	Issue No.	1
LM End	0.50	Issue Type +	En	Location *	LS
Category	Earthen Levee			GPS Latitude/Longitude	
				Start	End
Item	Encroachments			38.043682 °	38.043511 °
				-121.370390 °	-121.368500 °
DWR ID	DWR_NA0017_07_s_2012_1				
Action/Comments					
Fence

View of the fence along landside toe of the levee looking upstream.

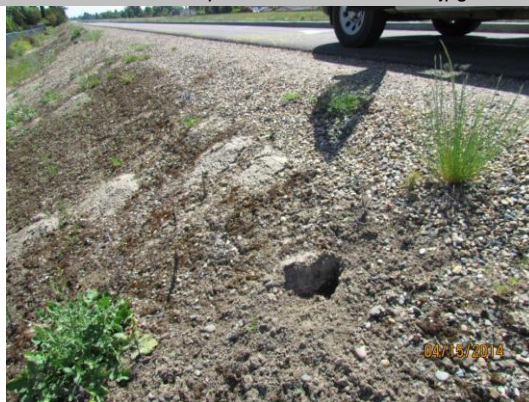
Photo 1 of 1 : pkazi_s_20140418_867.jpg

View of an animal hole on the landside of the levee looking upstream.

LM Start	0.66	Rating **	M	Issue No.	12
LM End	0.66	Issue Type +	Ma	Location *	LS
Category	Earthen Levee			GPS Latitude/Longitude	
				Start	End
Item	Animal Control			38.043574 °	38.043574 °
				-121.365620 °	-121.365620 °
DWR ID	DWR_NA0017_07_s_2014_12				
Action/Comments					
No rodents visible, but rodent burrows visible; need to backfill and compact or grout burrows.

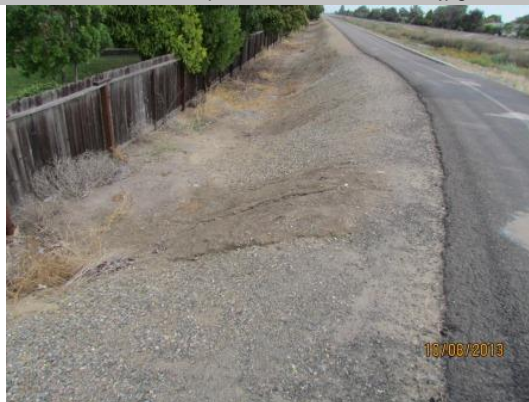
Photo 1 of 1 : pkazi_s_20140415_122.jpg

Runoff was found on the landside of the levee looking upstream.

LM Start	2.03	Rating **	M	Issue No.	13
LM End	2.03	Issue Type +	Ma	Location *	LS
Category	Earthen Levee			GPS Latitude/Longitude	
				Start	End
Item	Erosion / Bank Caving			38.043296 °	38.043296 °
				-121.341222 °	-121.341222 °
DWR ID	DWR_NA0017_07_f_2013_13				
Action/Comments					
Schedule repair of erosion site prior to the next inspection. Inspector Comments: Runoff on the landside slope.

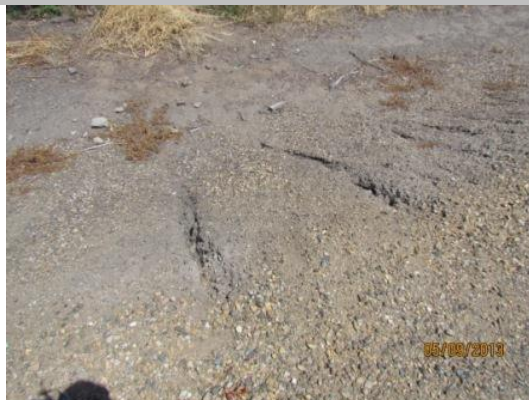
Photo 1 of 1 : pkazi_s_20140415_117.jpg

Erosion caused by runoff was found on the landside of the levee looking upstream.

LM Start	2.34	Rating **	M	Issue No.	7
LM End	2.34	Issue Type +	Ma	Location *	LS
Category	Earthen Levee			GPS Latitude/Longitude	
				Start	End
Item	Slope Stability			38.043225 °	38.043225 °
				-121.335815 °	-121.335815 °
DWR ID	DWR_NA0017_07_s_2013_7				
Action/Comments					
Repair slope instability.

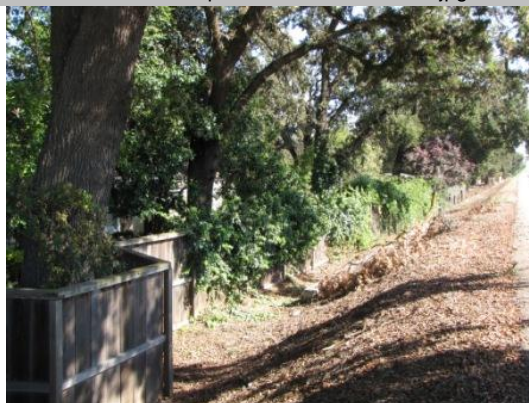
Photo 1 of 1 : pkazi_s_20140415_175.jpg

LM Start	2.57	Rating **	M	Issue No.	1033
LM End	2.65	Issue Type +	En	Location *	LS
Category	Earthen Levee			GPS Latitude/Longitude	
				Start	End
Item	Encroachments			38.043175 °	38.043177 °
				-121.331472 °	-121.330183 °
DWR ID	DWR_NA0017_07_s _ 2012_1033				
Action/Comments					
Fence					
Inspector Comments: Wood & metal fences

View of a wood fence adjacent to the landward toe looking upstream.

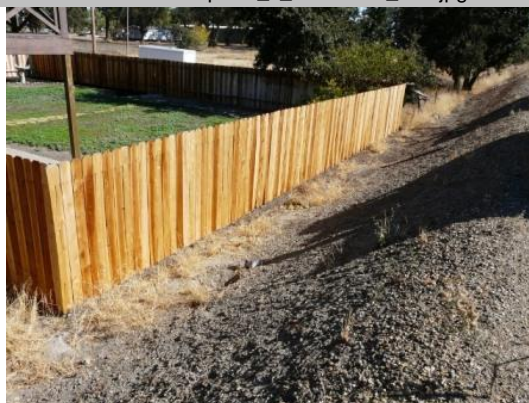
Photo 1 of 1 : pkazi_s_20140415_132.jpg

LM Start	2.66	Rating **	U	Issue No.	26
LM End	2.67	Issue Type +	En	Location *	LS
Category	Earthen Levee			GPS Latitude/Longitude	
				Start	End
Item	Encroachments			38.043182 °	38.043179 °
				-121.329790 °	-121.329613 °
DWR ID	DWR_NA0017_07_s _ 2012_26				
Action/Comments					
Fence

Newer fence built within landside toe of levee at from LM 2.66 to LM 2.67.

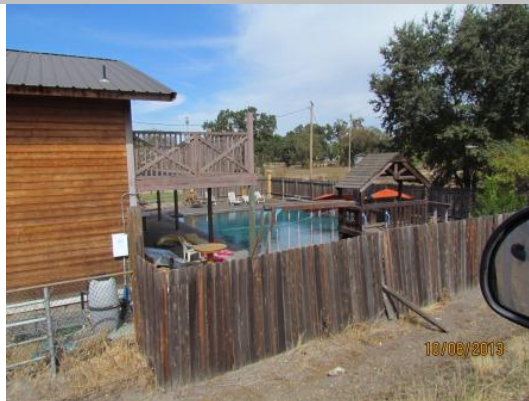
Photo 1 of 3 : pkazi_s_20140415_147.jpg

LM Start	2.67	Rating **	M	Issue No.	50
LM End	2.67	Issue Type +	En	Location *	LS
Category	Earthen Levee			GPS Latitude/Longitude	
				Start	End
Item	Encroachments			38.043189 °	38.043189 °
				-121.329810 °	-121.329810 °
DWR ID	DWR_NA0017_07_s _ 2012_50				
Action/Comments					
Pool					
Inspector Comments: New pool being built without a permit. The top of the pool is outside of the assumed easement, but it is deep enough that it may need some attention.

View of the pool on the landside toe of the levee looking upstream during fall 2013 inspection.

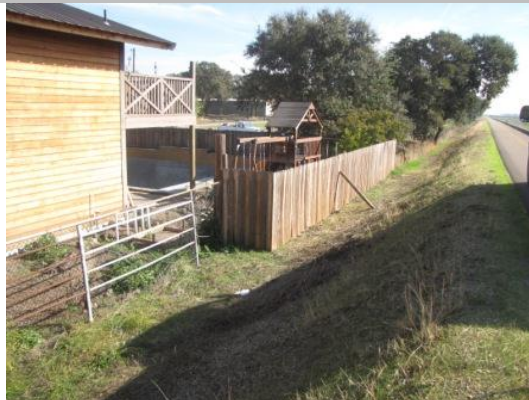
Photo 2 of 3 : pkazi_s_20140415_146.jpg

View of a recently constructed pool looking upstream.

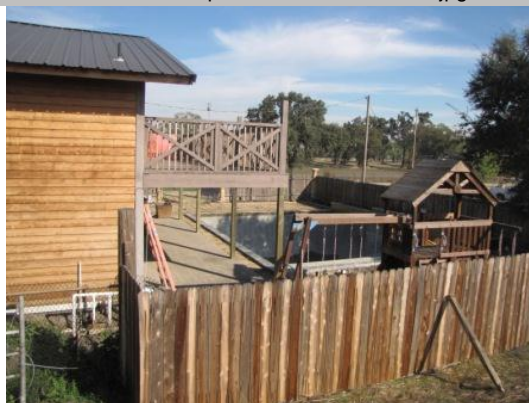
Photo 3 of 3 : pkazi_s_20140415_145.jpg

LM Start	2.67	Rating **	M	Issue No.	50 (cont)
LM End	2.67	Issue Type +	En	Location *	LS
Category	Earthen Levee			GPS Latitude/Longitude	
				Start	End
Item	Encroachments			38.043189 °	38.043189 °
				-121.329810 °	-121.329810 °
DWR ID	DWR_NA0017_07_s_2012_50				
Action/Comments					
Pool

View of a recently constructed pool looking landward.

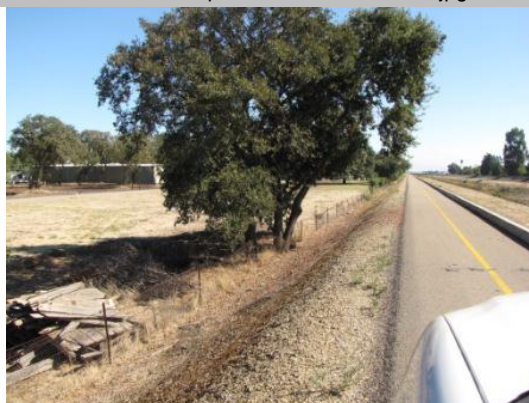
Photo 1 of 1 : pkazi_s_20140415_176.jpg

LM Start	2.68	Rating **	M	Issue No.	1034
LM End	3.04	Issue Type +	En	Location *	LS
Category	Earthen Levee			GPS Latitude/Longitude	
				Start	End
Item	Encroachments			38.043160 °	38.043166 °
				-121.329618 °	-121.323143 °
DWR ID	DWR_NA0017_07_s_2012_1034				
Action/Comments					
Fence					
Inspector Comments: Metal fence

View of a metal fence adjacent to the landward toe looking upstream.

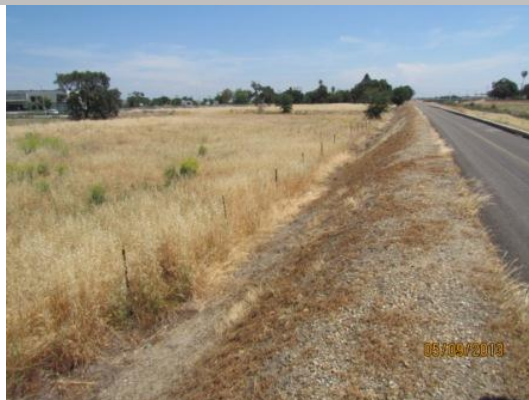
Photo 1 of 1 : pkazi_s_20140415_118.jpg

LM Start	2.84	Rating **	M	Issue No.	8
LM End	3.13	Issue Type +	En	Location *	LS
Category	Earthen Levee			GPS Latitude/Longitude	
				Start	End
Item	Encroachments			38.043156 °	38.043167 °
				-121.326670 °	-121.321592 °
DWR ID	DWR_NA0017_07_s_2013_8				
Action/Comments					
Fence

Fences were found on the landside toe of the levee looking upstream.

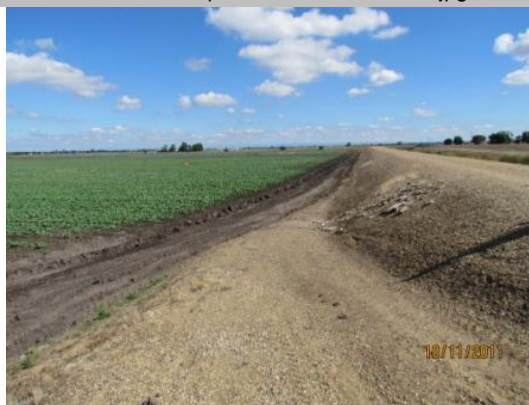
Photo 1 of 2 : pkazi_s_20140415_168.jpg

LM Start	3.16	Rating **	M	Issue No.	778
LM End	3.35	Issue Type +	En	Location *	LS
Category	Earthen Levee			GPS Latitude/Longitude	
				Start	End
Item	Encroachments			38.043164 °	38.043160 °
				-121.320946 °	-121.317532 °
DWR ID	DWR_NA0017_07_s_2012_778				
Action/Comments					
Ditch Inspector Comments: Farmer discing the toe of the levee.

Farmer discing the toe of the landside of the levee looking upstream.

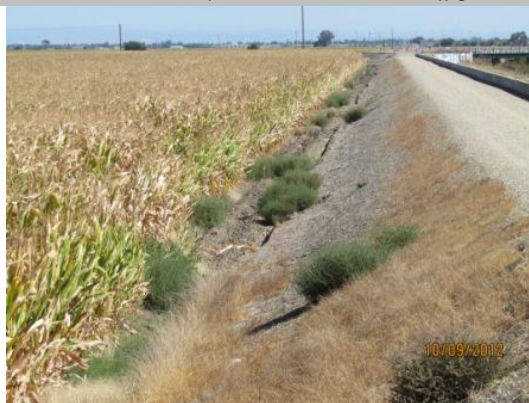
Photo 2 of 2 : pkazi_s_20140415_169.jpg

Updated picture of the toe cutting on the landside toe of the levee looking upstream.

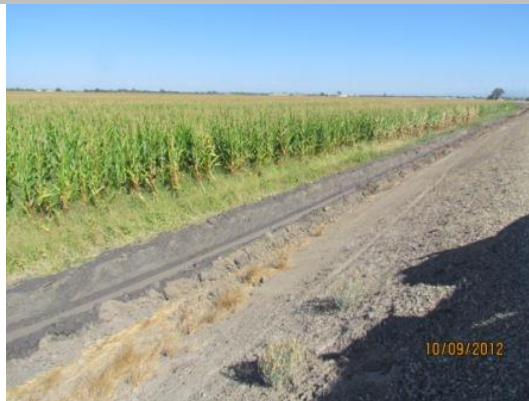
Photo 1 of 1 : pkazi_s_20140415_158.jpg

LM Start	4.10	Rating **	M	Issue No.	70
LM End	4.21	Issue Type +	En	Location *	LS
Category	Earthen Levee			GPS Latitude/Longitude	
				Start	End
Item	Encroachments			38.042963 °	38.042990 °
				-121.304235 °	-121.302329 °
DWR ID	DWR_NA0017_07_f_2012_70				
Action/Comments					
Ditch

A ditch was found on the landside toe of the levee looking upstream.

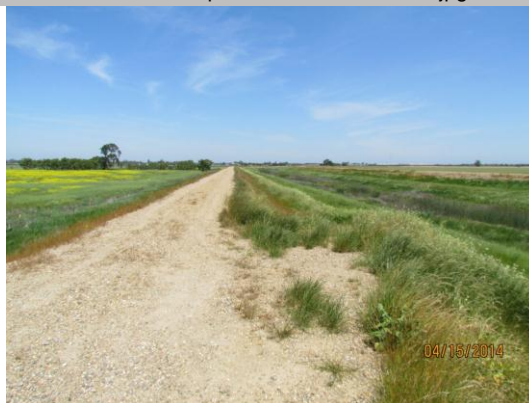
Photo 1 of 1 : pkazi_s_20140418_869.jpg

Vegetation on the waterside of the levee looking upstream.

LM Start	4.65	Rating **	M	Issue No.	34
LM End	5.84	Issue Type +	Ma	Location *	WS
Category	Earthen Levee			GPS Latitude/Longitude	
				Start	End
Item	Vegetation			38.044976 °	38.052755 °
				-121.295032 °	-121.277911 °
DWR ID	DWR_NA0017_07_s_2014_34				
Action/Comments					
Control annual grass and weeds on the levee slopes and easements.

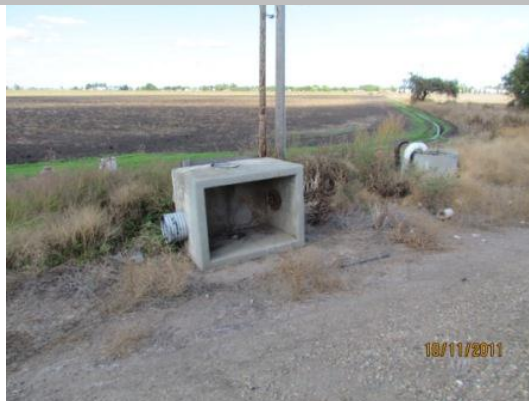
Photo 1 of 1 : pkazi_s_20140415_171.jpg

LM Start	5.28	Rating **	M	Issue No.	787
LM End	5.28	Issue Type +	En	Location *	LS
Category	Earthen Levee			GPS Latitude/Longitude	
				Start	End
Item	Encroachments			38.050315 °	38.050315 °
				-121.287011 °	-121.287011 °
DWR ID	DWR_NA0017_07_s_2012_787				
Action/Comments					
Debris

Abandoned culvert joint was found on the landside toe of the levee looking upstream.

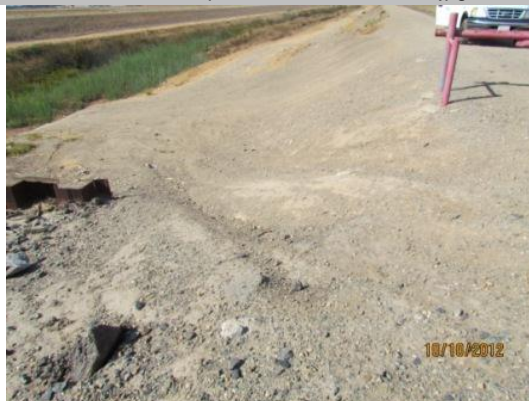
Photo 1 of 1 : pkazi_s_20140415_160.jpg

Slope instability was found on the landside of the levee looking upstream.

LM Start	5.85	Rating **	M	Issue No.	73
LM End	5.85	Issue Type +	Ma	Location *	WS
Category	Earthen Levee			GPS Latitude/Longitude	
				Start	End
Item	Slope Stability			38.052753 °	38.052753 °
				-121.277680 °	-121.277680 °
DWR ID	DWR_NA0017_07_f_2012_73				
Action/Comments					
Repair the levee slope damaged by vehicle traffic and prevent access where possible.

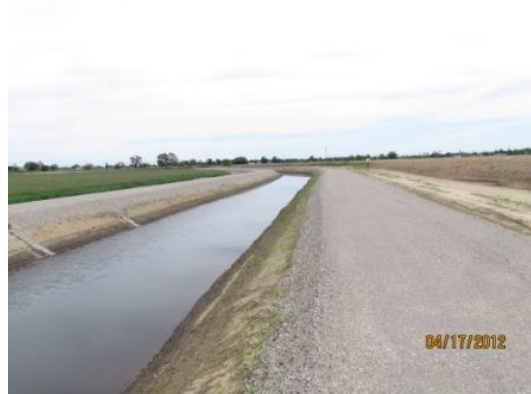
Photo 1 of 2 : pkazi_s_20140415_127.jpg

LM Start	6.24	Rating **	A/W	Issue No.	22
LM End	6.24	Issue Type +	En	Location *	LS
Category	Earthen Levee			GPS Latitude/Longitude	
				Start	End
Item	Encroachments			38.053609 °	38.053609 °
				-121.270838 °	-121.270838 °
DWR ID	DWR_NA0017_07_s _ 2012_22				
Action/Comments					
Ditch Inspector Comments: Woodbridge irrigation dug 20 feet wide channel 20 feet away from the toe of the levee. For details, please see Field Investigation Report #4581. According to their calculations, the ditch is away from the levee prism.

A 20 feet wide channel was dug on the landside of the levee looking upstream.

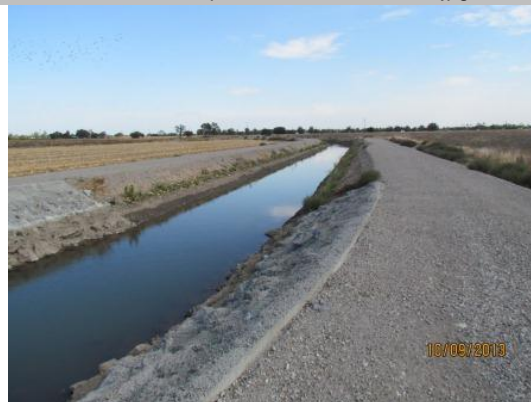
Photo 2 of 2 : pkazi_s_20140415_128.jpg

LM Start	6.24	Rating **	A/W	Issue No.	22 (cont)
LM End	6.24	Issue Type +	En	Location *	LS

Updated picture of the ditch near the landside toe of the levee looking upstream.

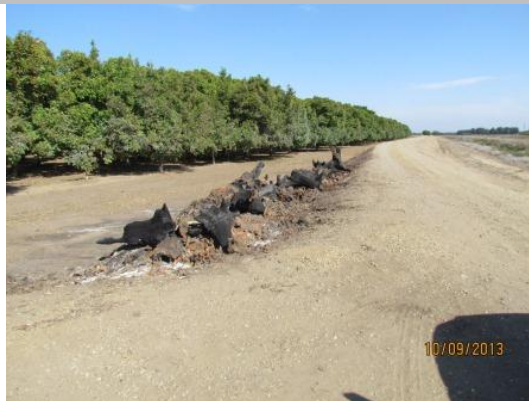
Photo 2 of 2 : pkazi_s_20140415_136.jpg

LM Start	9.18	Rating **	M	Issue No.	31 (cont)
LM End	9.18	Issue Type +	Ma	Location *	LS
Category	Earthen Levee			GPS Latitude/Longitude	
				Start	End
Item	Encroachments			38.070231 °	38.070231 °
				-121.226677 °	-121.226677 °
DWR ID	DWR_NA0017_07_s _ 2012_31				
Action/Comments					
Prunings					
Inspector Comments: Burn pile has been burned but new material has been placed.

Updated picture of the burning piles on the landside of the levee looking upstream.

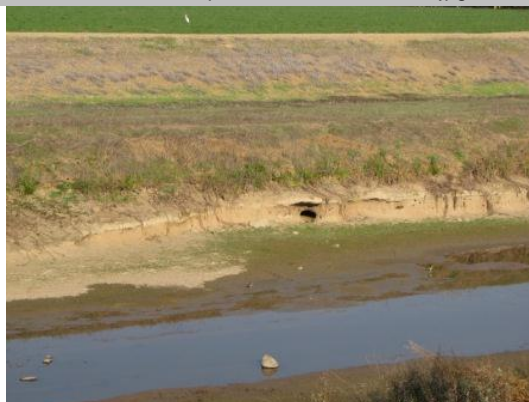
Photo 1 of 1 : pkazi_s_20140415_161.jpg

LM Start	9.65	Rating **	U	Issue No.	80
LM End	9.65	Issue Type +	Ma	Location *	WS
Category	Earthen Levee			GPS Latitude/Longitude	
				Start	End
Item	Animal Control			38.070458 °	38.070458 °
				-121.218596 °	-121.218596 °
DWR ID	DWR_NA0017_07_s _ 2012_80				
Action/Comments					
No rodents visible, but rodent burrows visible; need to backfill and compact or grout burrows. Inspector Comments: Beaver den in the waterward berm visible from the opposite bank.

View of a large hole and several smaller holes from across the channel.

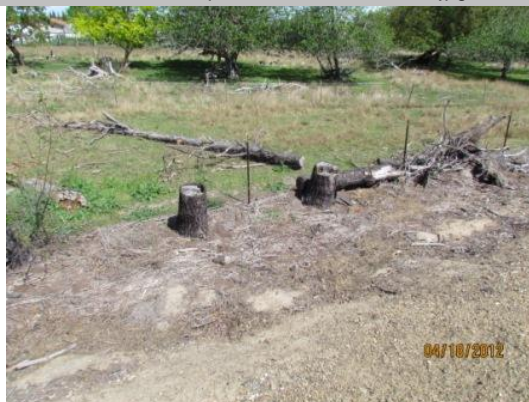
Photo 1 of 1 : pkazi_s_20140415_143.jpg

LM Start	10.23	Rating **	N	Issue No.	46
LM End	10.23	Issue Type +	Ma	Location *	LS
Category	Earthen Levee			GPS Latitude/Longitude	
				Start	End
Item	Trim / Thin Trees			38.074613 °	38.074613 °
				-121.209882 °	-121.209882 °
DWR ID	DWR_NA0017_07_s _ 2012_46				
Action/Comments					
Tree stumps.

Tree stumps were found on the landside of the levee looking upstream.

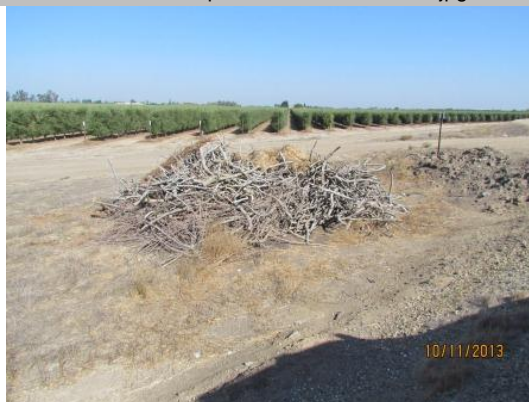
Photo 1 of 1 : pkazi_s_20140415_142.jpg

LM Start	11.73	Rating **	M	Issue No.	44
LM End	11.73	Issue Type +	En	Location *	LS
Category	Earthen Levee			GPS Latitude/Longitude	
				Start	End
Item	Encroachments			38.086900 °	38.086900 °
				-121.189617 °	-121.189617 °
DWR ID	DWR_NA0017_07_f_2013_44				
Action/Comments					
Prunings

Prunings were found on the landside of the levee looking upstream.

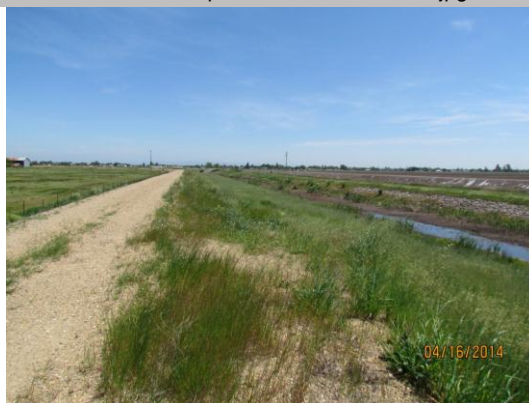
Photo 1 of 1 : pkazi_s_20140418_875.jpg

LM Start	12.41	Rating **	M	Issue No.	66
LM End	12.92	Issue Type +	Ma	Location *	WS
Category	Earthen Levee			GPS Latitude/Longitude	
				Start	End
Item	Vegetation			38.092331 °	38.097294 °
				-121.180900 °	-121.176515 °
DWR ID	DWR_NA0017_07_s_2014_66				
Action/Comments					
Control annual grass and weeds on the levee slopes and easements.

Vegetation on the waterside of the levee looking upstream.

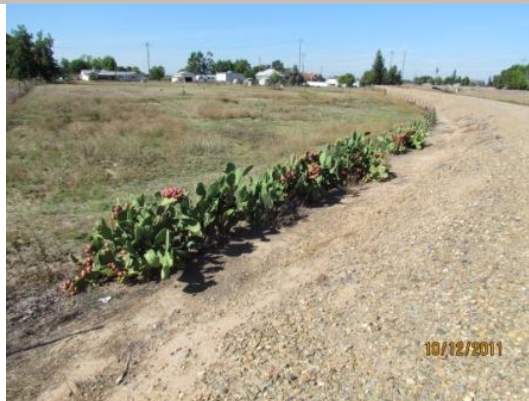
Photo 1 of 1 : pkazi_s_20140415_140.jpg

LM Start	13.06	Rating **	M	Issue No.	42
LM End	13.06	Issue Type +	En	Location *	LS
Category	Earthen Levee			GPS Latitude/Longitude	
				Start	End
Item	Vegetation			38.099206 °	38.099206 °
				-121.176350 °	-121.176350 °
DWR ID	DWR_NA0017_07_s _ 2012_42				
Action/Comments					
Landscaping					
Inspector Comments: Cacti on landward toe and through fence.

Cacti were found on the toe of landside of the levee looking upstream.

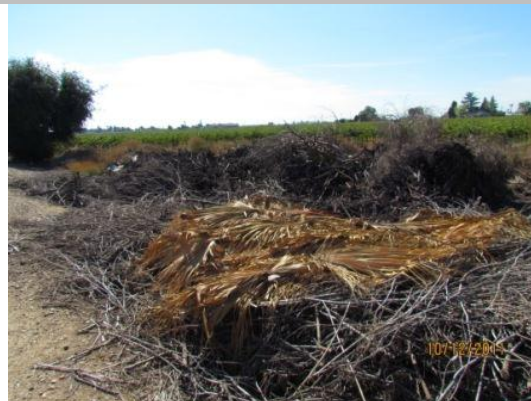
Photo 1 of 1 : pkazi_s_20140415_172.jpg

LM Start	13.98	Rating **	M	Issue No.	807
LM End	13.98	Issue Type +	En	Location *	LS
Category	Earthen Levee			GPS Latitude/Longitude	
				Start	End
Item	Encroachments			38.110753 °	38.110753 °
				-121.172829 °	-121.172829 °
DWR ID	DWR_NA0017_07_s_2012_807				
Action/Comments					
Debris

Pruning and debris were found on the landside of the levee looking downstream.

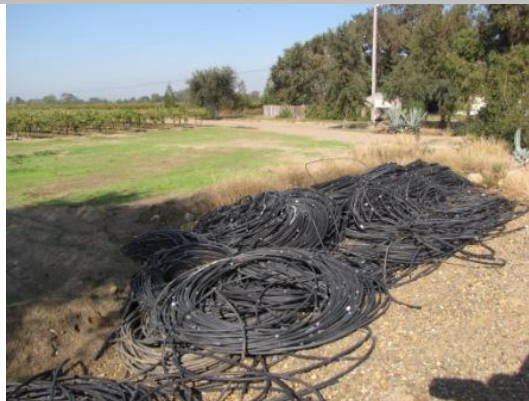
Photo 1 of 1 : pkazi_s_20140415_177.jpg

LM Start	13.99	Rating **	M	Issue No.	1053
LM End	13.99	Issue Type +	En	Location *	LS
Category	Earthen Levee			GPS Latitude/Longitude	
				Start	End
Item	Encroachments			38.111026 °	38.111026 °
				-121.172823 °	-121.172823 °
DWR ID	DWR_NA0017_07_s_2012_1053				
Action/Comments					
Material

View of irrigation pipe on the landward slope.

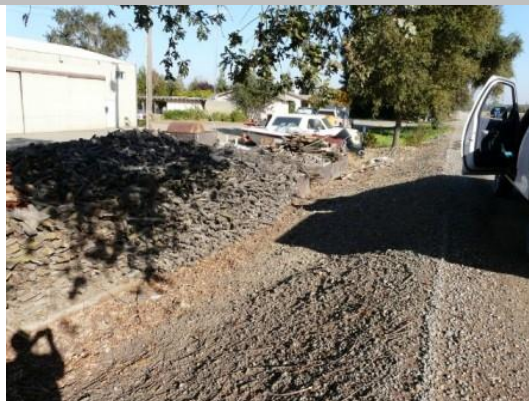
Photo 1 of 1 : pkazi_s_20140415_139.jpg

LM Start	14.08	Rating **	M	Issue No.	39
LM End	14.08	Issue Type +	Ma	Location *	LS
Category	Earthen Levee			GPS Latitude/Longitude	
				Start	End
Item	Encroachments			38.111902 °	38.111902 °
				-121.172685 °	-121.172685 °
DWR ID	DWR_NA0017_07_s_2012_39				
Action/Comments					
Firewood

Move firewood to outside of 10' from landside toe of levee at LM 14.08.

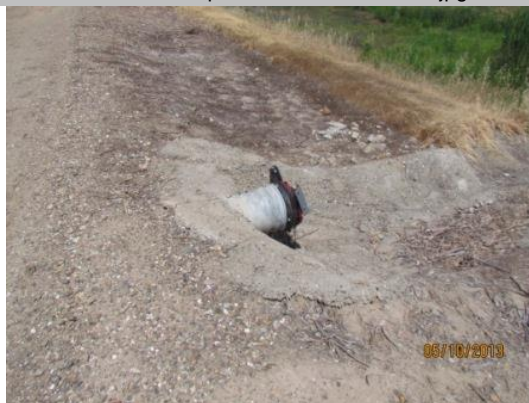
Photo 1 of 2 : pkazi_s_20140415_163.jpg

LM Start	14.40	Rating **	A	Issue No.	94
LM End	14.40	Issue Type +	En	Location *	WS
Category	Earthen Levee			GPS Latitude/Longitude	
				Start	End
Item	Encroachments			38.116796 °	38.116796 °
				-121.172104 °	-121.172104 °
DWR ID	DWR_NA0017_07_f_2012_94				
Action/Comments					
Pipe					
Inspector Comments: A flap gate was installed at the end of the pipe.

A flap gate was installed on a pipe located on the waterside slope of the levee looking upstream.

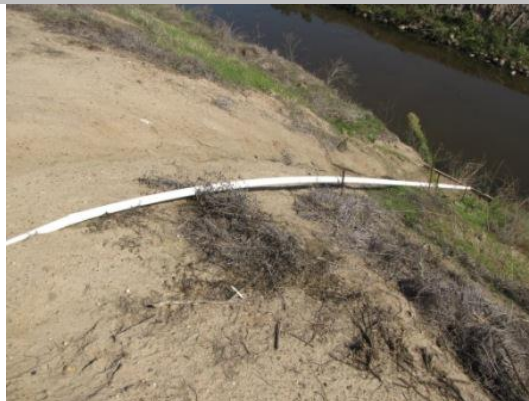
Photo 1 of 1 : pkazi_s_20140415_178.jpg

LM Start	14.77	Rating **	M	Issue No.	1054
LM End	14.77	Issue Type +	Ma	Location *	WS
Category	Earthen Levee			GPS Latitude/Longitude	
				Start	End
Item	Encroachments			38.121661 °	38.121661 °
				-121.169548 °	-121.169548 °
DWR ID	DWR_NA0017_07_s _ 2012_1054				
Action/Comments					
Pipe Inspector Comments: Landowner has installed a pipe in the access road to take water from the channel for irrigation. Steps have also been dug into the side of the channel.

View of a pipe a landowner placed in the access road and waterward slope to pump water from the channel to irrigate their garden.

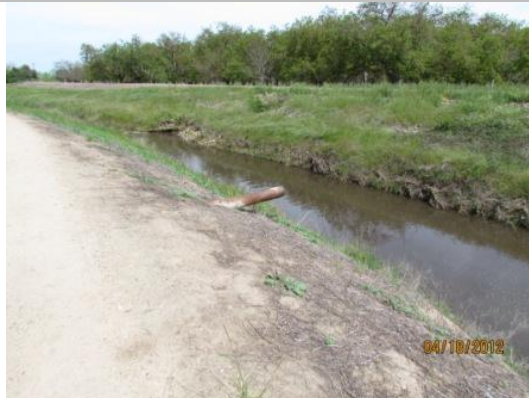
Photo 1 of 1 : pkazi_s_20140415_152.jpg

LM Start	14.79	Rating **	M	Issue No.	59
LM End	14.79	Issue Type +	En	Location *	WS
Category	Earthen Levee			GPS Latitude/Longitude	
				Start	End
Item	Encroachments			38.121912 °	38.121912 °
				-121.169421 °	-121.169421 °
DWR ID	DWR_NA0017_07_s _ 2012_59				
Action/Comments					
Pipe

A corroded pipe was found on the waterside of the levee looking upstream.

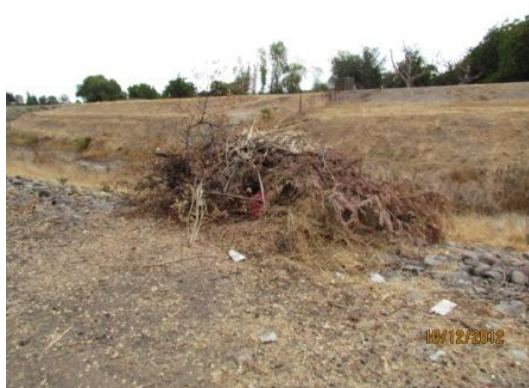
Photo 1 of 2 : pkazi_s_20140415_164.jpg

LM Start	14.90	Rating **	M	Issue No.	95
LM End	14.90	Issue Type +	En	Location *	WS
Category	Earthen Levee			GPS Latitude/Longitude	
				Start	End
Item	Encroachments			38.123415 °	38.123415 °
				-121.169666 °	-121.169666 °
DWR ID	DWR_NA0017_07_f_2012_95				
Action/Comments					
Prunings

Prunings were found on the waterside of the levee looking upstream.

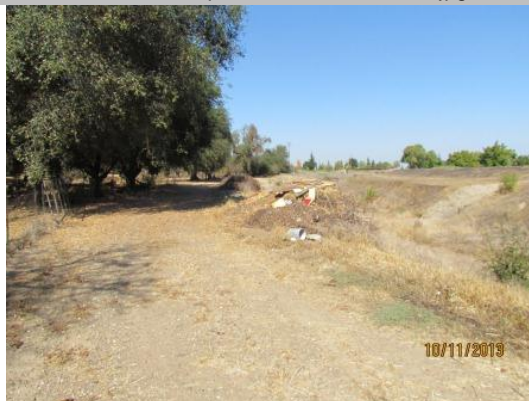
Photo 2 of 2 : pkazi_s_20140415_165.jpg

LM Start	14.90	Rating **	M	Issue No.	95 (cont)
LM End	14.90	Issue Type +	En	Location *	WS

Updated picture of the prunings on the waterside shoulder of the levee looking upstream.

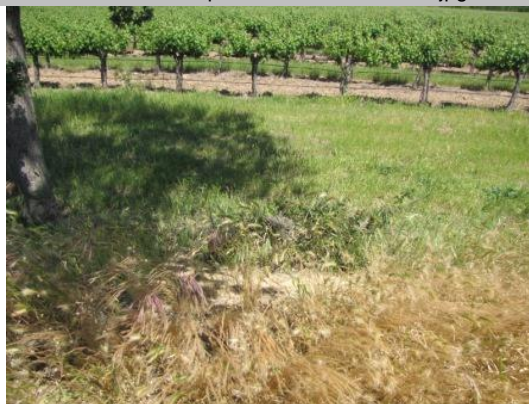
Photo 1 of 1 : pkazi_s_20140415_150.jpg

LM Start	15.60	Rating **	N	Issue No.	53
LM End	15.72	Issue Type +	Ma	Location *	LS
Category	Earthen Levee			GPS Latitude/Longitude	
				Start	End
Item	Trim / Thin Trees			38.129236 °	38.130205 °
				-121.160163 °	-121.158466 °
DWR ID	DWR_NA0017_07_s _ 2012_53				
Action/Comments					
Tree stumps.

View of a stump in the landward slope.

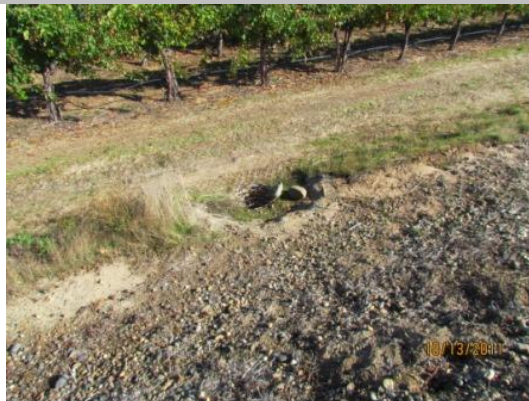
Photo 1 of 1 : pkazi_s_20140415_173.jpg

LM Start	15.77	Rating **	M	Issue No.	809
LM End	15.77	Issue Type +	En	Location *	LS
Category	Earthen Levee			GPS Latitude/Longitude	
				Start	End
Item	Encroachments			38.130303 °	38.130303 °
				-121.157451 °	-121.157451 °
DWR ID	DWR_NA0017_07_s_2012_809				
Action/Comments					
Pipe					
Inspector Comments: Drain is located at the landside toe of the levee.

A drain was found at the toe of landside of the levee. The picture was taken from the crown looking towards the toe.

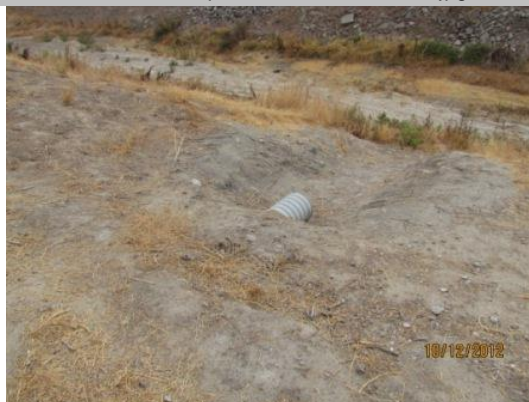
Photo 1 of 1 : pkazi_s_20140415_167.jpg

LM Start	16.07	Rating **	M	Issue No.	99
LM End	16.07	Issue Type +	En	Location *	LS
Category	Earthen Levee			GPS Latitude/Longitude	
				Start	End
Item	Encroachments			38.132581 °	38.132581 °
				-121.153872 °	-121.153872 °
DWR ID	DWR_NA0017_07_f_2012_99				
Action/Comments					
Pipe

A pipe was found on the waterside slope of the levee looking upstream.

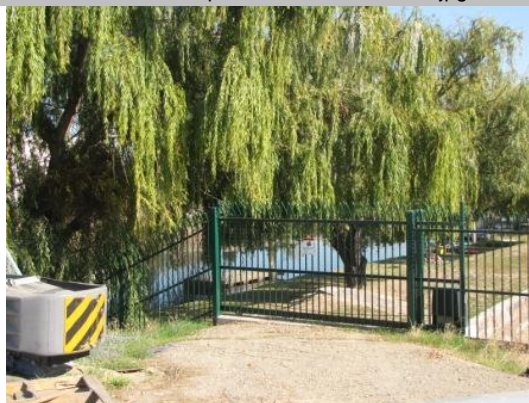
Photo 1 of 1 : pkazi_s_20140415_248.jpg

LM Start	0.78	Rating **	M	Issue No.	1054
LM End	0.78	Issue Type +	En	Location *	CR
Category	Earthen Levee			GPS Latitude/Longitude	
				Start	End
Item	Encroachments			38.053178 °	38.053178 °
				-121.375387 °	-121.375387 °
DWR ID	DWR_NA0017_08_s _ 2012_1054				
Action/Comments					
Fence

View of a open fence and gate across the crown at the current start of the unit looking upstream. Limited access has been provided.

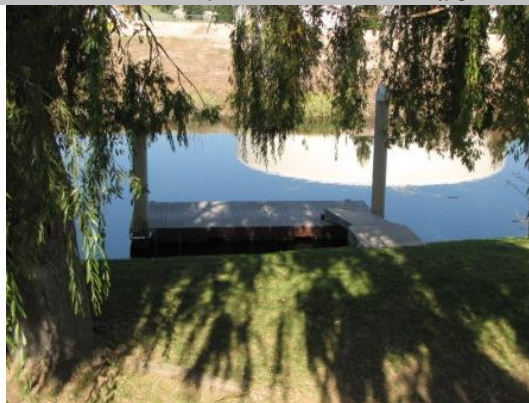
Photo 1 of 2 : pkazi_s_20140415_251.jpg

LM Start	0.79	Rating **	M	Issue No.	1057
LM End	0.79	Issue Type +	En	Location *	WS
Category	Earthen Levee			GPS Latitude/Longitude	
				Start	End
Item	Encroachments			38.053178 °	38.053178 °
				-121.375387 °	-121.375387 °
DWR ID	DWR_NA0017_08_s _ 2012_1057				
Action/Comments					
Building					
Inspector Comments: Dock on waterward berm.

View of a dock off the waterward berm.

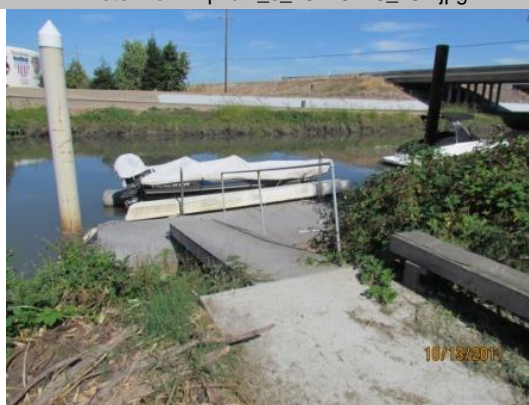
Photo 2 of 2 : pkazi_s_20140415_252.jpg

LM Start	0.79	Rating **	M	Issue No.	1057 (cont)
LM End	0.79	Issue Type +	En	Location *	WS

View of the dock at the waterside of the levee during fall 2011 inspection. The picture was taken from the crown looking upstream.

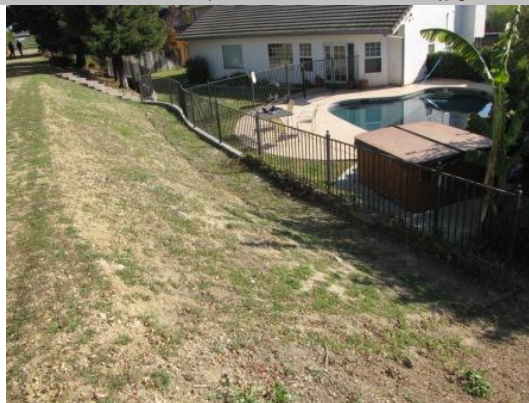
Photo 1 of 1 : pkazi_s_20140415_253.jpg

LM Start	0.79	Rating **	M	Issue No.	1060
LM End	0.81	Issue Type +	En	Location *	LS
Category	Earthen Levee			GPS Latitude/Longitude	
				Start	End
Item	Encroachments			38.053178 °	38.053178 °
				-121.375387 °	-121.375387 °
DWR ID	DWR_NA0017_08_s _ 2012_1060				
Action/Comments					
Fence

View of a fence on top of a retaining wall in the landward toe of the levee. Some landscaping and irrigation are also present.

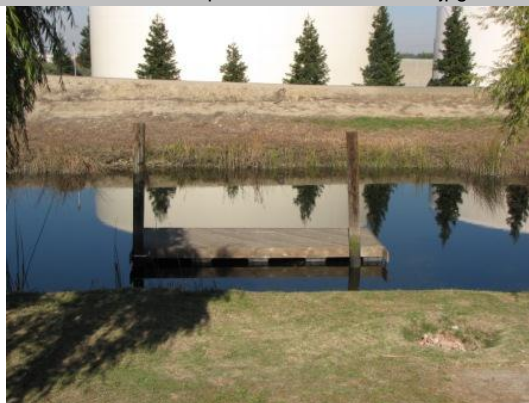
Photo 1 of 1 : pkazi_s_20140415_254.jpg

LM Start	0.80	Rating **	M	Issue No.	1061
LM End	0.80	Issue Type +	En	Location *	WS
Category	Earthen Levee			GPS Latitude/Longitude	
				Start	End
Item	Encroachments			38.053178 °	38.053178 °
				-121.375387 °	-121.375387 °
DWR ID	DWR_NA0017_08_s _ 2012_1061				
Action/Comments					
Building					
Inspector Comments: Dock on waterward side of berm.

View of a dock off the waterward side of the berm.

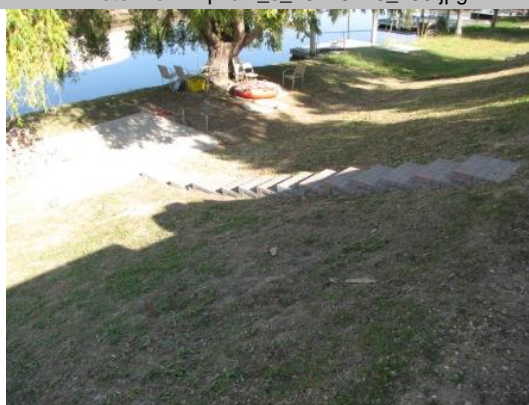
Photo 1 of 2 : pkazi_s_20140415_255.jpg

LM Start	0.80	Rating **	A/W	Issue No.	1062
LM End	0.80	Issue Type +	En	Location *	WS
Category	Earthen Levee			GPS Latitude/Longitude	
				Start	End
Item	Encroachments			38.053178 °	38.053178 °
				-121.375387 °	-121.375387 °
DWR ID	DWR_NA0017_08_s _ 2012_1062				
Action/Comments					
Stairway					
Inspector Comments: Stairs and patio on waterward side and slope.

View of stairs and patio on the waterward slope and berm looking upstream.

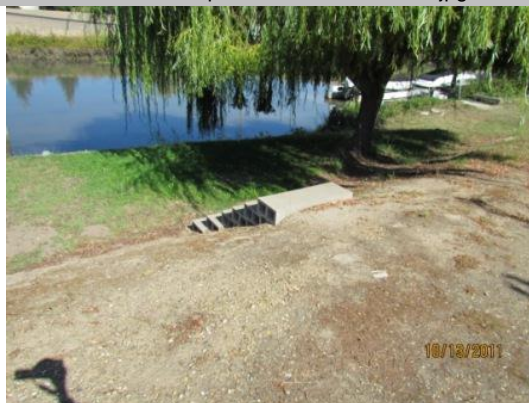
Photo 2 of 2 : pkazi_s_20140415_256.jpg

LM Start	0.80	Rating **	A/W	Issue No.	1062 (cont)
LM End	0.80	Issue Type +	En	Location *	WS

Stairway on the waterside slope of the levee during fall 2011 inspection.

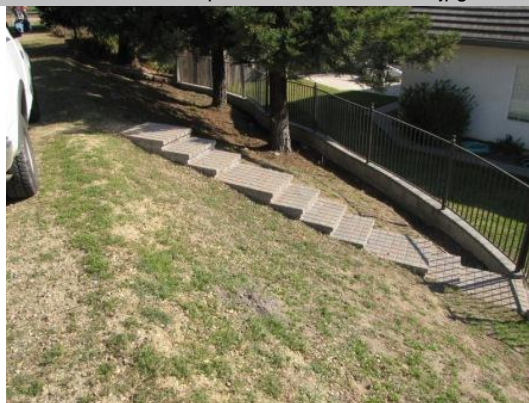
Photo 1 of 1 : pkazi_s_20140415_265.jpg

LM Start	0.80	Rating **	M	Issue No.	1075
LM End	0.80	Issue Type +	Ma	Location *	LS
Category	Earthen Levee			GPS Latitude/Longitude	
				Start	End
Item	Encroachments			38.053178 °	38.053178 °
				-121.375387 °	-121.375387 °
DWR ID	DWR_NA0017_08_s _ 2012_1075				
Action/Comments					
Stairway

View of steps on the landward slope looking upstream.

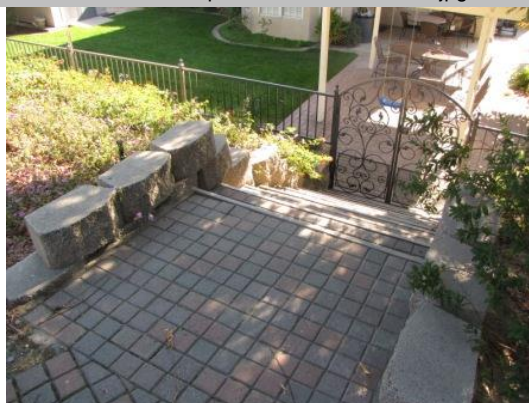
Photo 1 of 1 : pkazi_s_20140415_259.jpg

LM Start	0.81	Rating **	A/W	Issue No.	1065
LM End	0.81	Issue Type +	En	Location *	LS
Category	Earthen Levee			GPS Latitude/Longitude	
				Start	End
Item	Encroachments			38.053178 °	38.053178 °
				-121.375387 °	-121.375387 °
DWR ID	DWR_NA0017_08_s _ 2012_1065				
Action/Comments					
Stairway

View of steps on the landward slope.

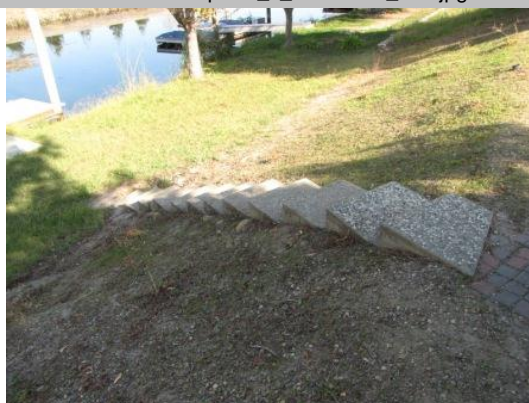
Photo 1 of 1 : pkazi_s_20140415_260.jpg

LM Start	0.81	Rating **	A/W	Issue No.	1066
LM End	0.81	Issue Type +	En	Location *	WS
Category	Earthen Levee			GPS Latitude/Longitude	
				Start	End
Item	Encroachments			38.053178 °	38.053178 °
				-121.375387 °	-121.375387 °
DWR ID	DWR_NA0017_08_s _ 2012_1066				
Action/Comments					
Stairway

View of steps on the waterward slope looking upstream.

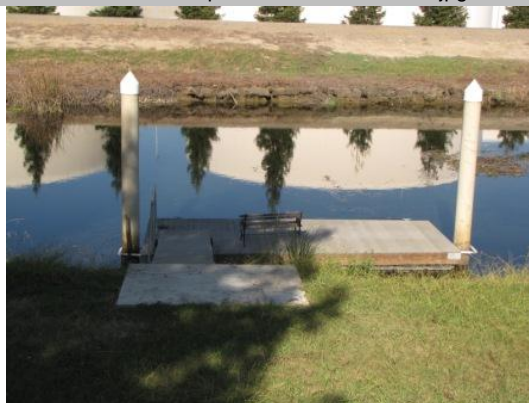
Photo 1 of 1 : pkazi_s_20140415_261.jpg

LM Start	0.81	Rating **	M	Issue No.	1067
LM End	0.81	Issue Type +	En	Location *	WS
Category	Earthen Levee			GPS Latitude/Longitude	
				Start	End
Item	Encroachments			38.053178 °	38.053178 °
				-121.375387 °	-121.375387 °
DWR ID	DWR_NA0017_08_s _ 2012_1067				
Action/Comments					
Building					
Inspector Comments: Dock on waterward side of berm.

View of a dock on the waterward side of the berm.

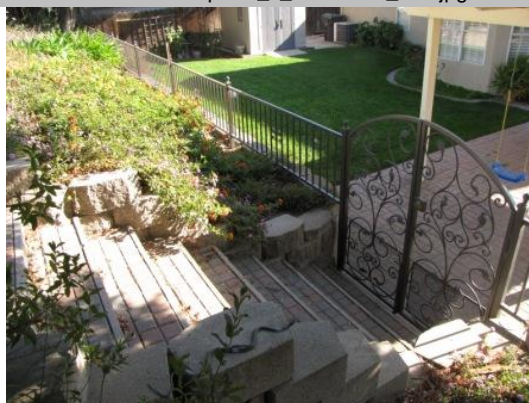
Photo 1 of 1 : pkazi_s_20140415_257.jpg

LM Start	0.81	Rating **	M	Issue No.	1063
LM End	0.82	Issue Type +	En	Location *	LS
Category	Earthen Levee			GPS Latitude/Longitude	
				Start	End
Item	Encroachments			38.053178 °	38.053178 °
				-121.375387 °	-121.375387 °
DWR ID	DWR_NA0017_08_s _ 2012_1063				
Action/Comments					
Fence					
Inspector Comments: Fence on short retaining wall cut into the landward toe.

View of a open fence on a retaining wall in the landward toe of the levee looking upstream.

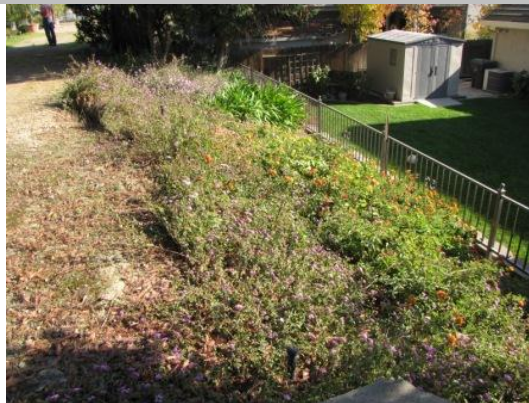
Photo 1 of 1 : pkazi_s_20140415_258.jpg

LM Start	0.81	Rating **	U	Issue No.	1064
LM End	0.82	Issue Type +	En	Location *	LS
Category	Earthen Levee			GPS Latitude/Longitude	
				Start	End
Item	Vegetation			38.053178 °	38.053178 °
				-121.375387 °	-121.375387 °
DWR ID	DWR_NA0017_08_s _ 2012_1064				
Action/Comments					
Landscaping Inspector Comments: Landscaping with irrigation (extends onto waterward side) on landward slope.

View of landscaping obstructing visibility and access and irrigation along the landward slope looking upstream.

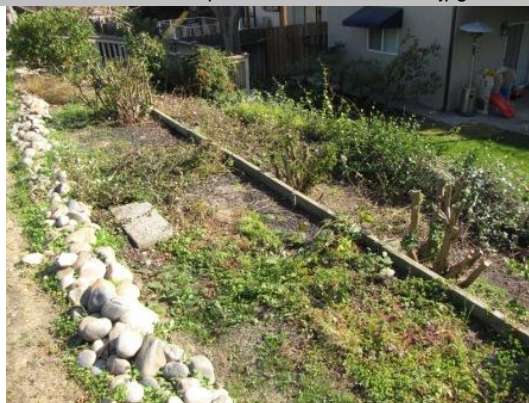
Photo 1 of 1 : pkazi_s_20140415_262.jpg

LM Start	0.82	Rating **	M	Issue No.	1068
LM End	0.83	Issue Type +	En	Location *	LS
Category	Earthen Levee			GPS Latitude/Longitude	
				Start	End
Item	Vegetation			38.053178 °	38.053178 °
				-121.375387 °	-121.375387 °
DWR ID	DWR_NA0017_08_s_2012_1068				
Action/Comments					
Landscaping Inspector Comments: Landscaping and irrigation on landward slope. There is also a waterfeature built into the slope. Fall 2010: Only the irrigation still exists and it is black tubing on the surface of the levee.

View of landscaping and irrigation along the landward slope looking upstream.

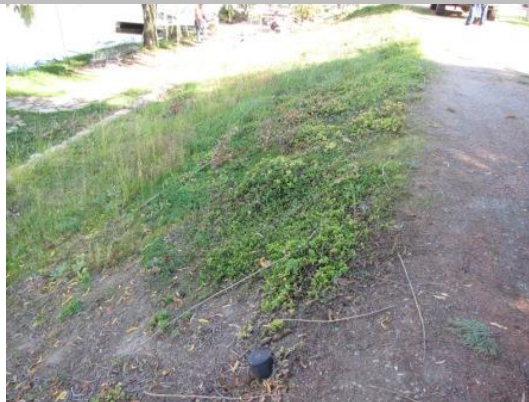
Photo 1 of 1 : pkazi_s_20140415_263.jpg

LM Start	0.82	Rating **	M	Issue No.	1071
LM End	0.83	Issue Type +	En	Location *	WS
Category	Earthen Levee			GPS Latitude/Longitude	
				Start	End
Item	Vegetation			38.053178 °	38.053178 °
				-121.375387 °	-121.375387 °
DWR ID	DWR_NA0017_08_s_2012_1071				
Action/Comments					
Landscaping Inspector Comments: Landscaping and irrigation along the waterward slope. Spring 2010 Update: Landscaping removed, irrigation still exists. Fall 2010: irrigation is now black tubing on the surface of the levee.

View of landscaping and irrigation on the waterward slope looking upstream.

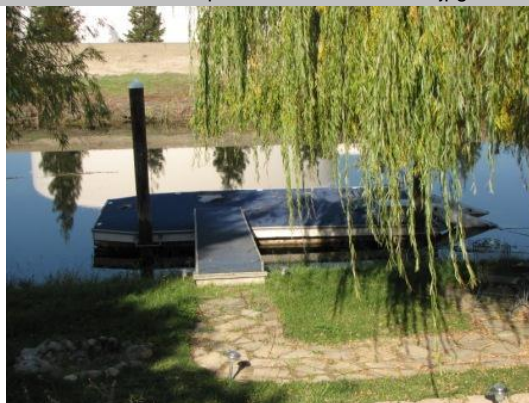
Photo 1 of 1 : pkazi_s_20140415_264.jpg

LM Start	0.82	Rating **	M	Issue No.	1072
LM End	0.82	Issue Type +	En	Location *	WS
Category	Earthen Levee			GPS Latitude/Longitude	
				Start	End
Item	Encroachments			38.053178 °	38.053178 °
				-121.375387 °	-121.375387 °
DWR ID	DWR_NA0017_08_s _ 2012_1072				
Action/Comments					
Building Inspector Comments: Dock on waterward side of berm.

View of a dock and pathway on the waterward side of the berm.

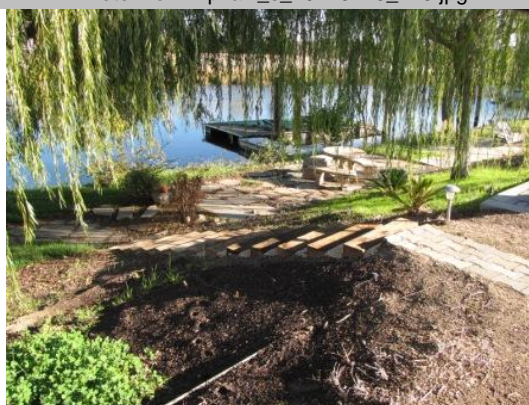
Photo 1 of 1 : pkazi_s_20140415_179.jpg

LM Start	0.83	Rating **	A/W	Issue No.	1
LM End	0.83	Issue Type +	Ma	Location *	LS
Category	Earthen Levee			GPS Latitude/Longitude	
				Start	End
Item	Encroachments			38.043110 °	38.043110 °
				-121.369538 °	-121.369538 °
DWR ID	DWR_NA0017_08_s _ 2012_1				
Action/Comments					
Stairway					
Inspector Comments: New stairs on waterward slope.

View of recently modified steps on the waterward slope of the levee looking upstream.

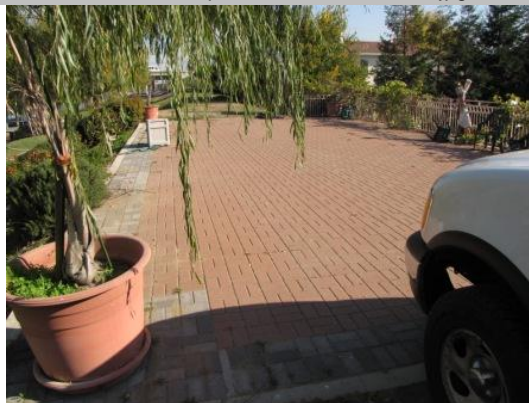
Photo 1 of 2 : pkazi_s_20140415_266.jpg

LM Start	0.83	Rating **	M	Issue No.	1076
LM End	0.84	Issue Type +	En	Location *	CR
Category	Earthen Levee			GPS Latitude/Longitude	
				Start	End
Item	Encroachments			38.053178 °	38.053178 °
				-121.375387 °	-121.375387 °
DWR ID	DWR_NA0017_08_s _ 2012_1076				
Action/Comments					
Building					
Inspector Comments: Pavers placed on crown of levee.

View of pavers placed on the crown of the levee looking upstream. Potted landscaping and irrigation can also be seen.

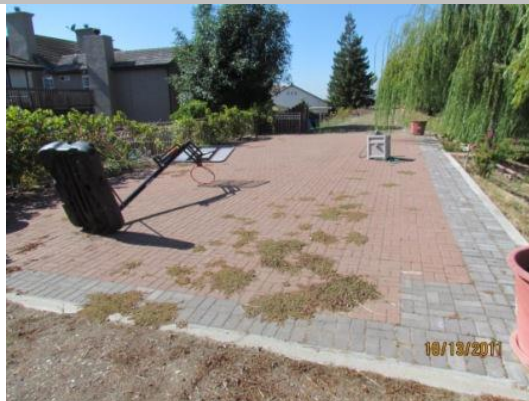
Photo 2 of 2 : pkazi_s_20140415_267.jpg

LM Start	0.83	Rating **	M	Issue No.	1076 (cont)
LM End	0.84	Issue Type +	En	Location *	CR
Category	Earthen Levee			GPS Latitude/Longitude	
				Start	End
Item	Encroachments			38.053178 °	38.053178 °
				-121.375387 °	-121.375387 °
DWR ID	DWR_NA0017_08_s _ 2012_1076				
Action/Comments					
Building					
Inspector Comments: Pavers placed on crown of levee.

View of pavers placed on the crown looking downstream. This picture was taken during fall 2011 inspection.

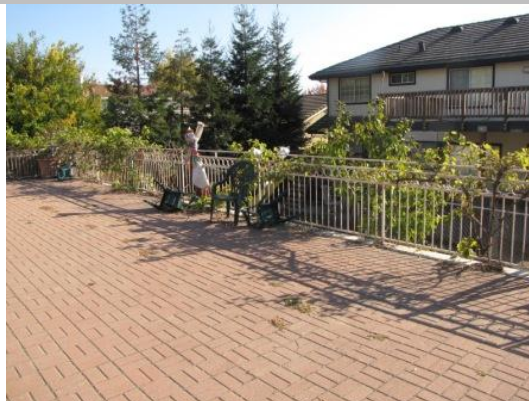
Photo 1 of 1 : pkazi_s_20140415_268.jpg

LM Start	0.83	Rating **	M	Issue No.	1077
LM End	0.84	Issue Type +	En	Location *	LS
Category	Earthen Levee			GPS Latitude/Longitude	
				Start	End
Item	Encroachments			38.053178 °	38.053178 °
				-121.375387 °	-121.375387 °
DWR ID	DWR_NA0017_08_s _ 2012_1077				
Action/Comments					
Fence					
Inspector Comments: Fence with landscaping along top of a large retaining wall in landward toe.

View of a fence on top of a large retaining wall in the landward slope looking upstream. Landscaping is growing along the fence.

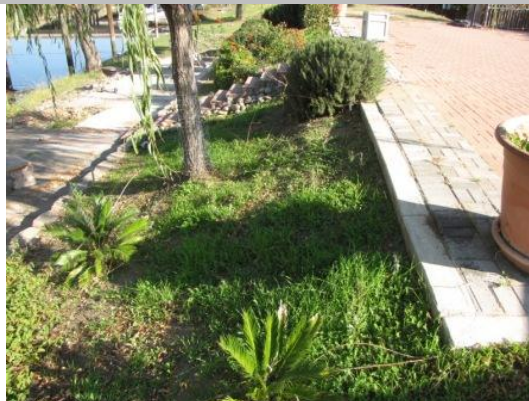
Photo 1 of 2 : pkazi_s_20140415_270.jpg

LM Start	0.83	Rating **	M	Issue No.	1079
LM End	0.84	Issue Type +	En	Location *	WS
Category	Earthen Levee			GPS Latitude/Longitude	
				Start	End
Item	Vegetation			38.053178 °	38.053178 °
				-121.375387 °	-121.375387 °
DWR ID	DWR_NA0017_08_s_2012_1079				
Action/Comments					
Landscaping					
Inspector Comments: Landscaping with irrigation along the waterward slope. Fall 2010: Most of the landscaping has been removed.

View of landscaping and irrigation on the waterward slope looking upstream.

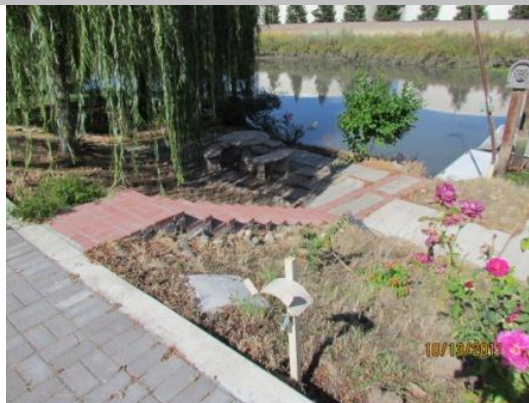
Photo 2 of 2 : pkazi_s_20140415_271.jpg

LM Start	0.83	Rating **	M	Issue No.	1079 (cont)
LM End	0.84	Issue Type +	En	Location *	WS

View of the landscaping on the waterside of the levee looking downstream. This picture was taken during fall 2011 inspection.
